HAZARDOUS WASTE SITE ASSESSMENT REPORT

Baltimore Steel Drum
~~BUCK-STEEL-DRUM~~

910 S. KRESSON STREET, BALTIMORE, MD

DATE: FEBRUARY 15, 1982

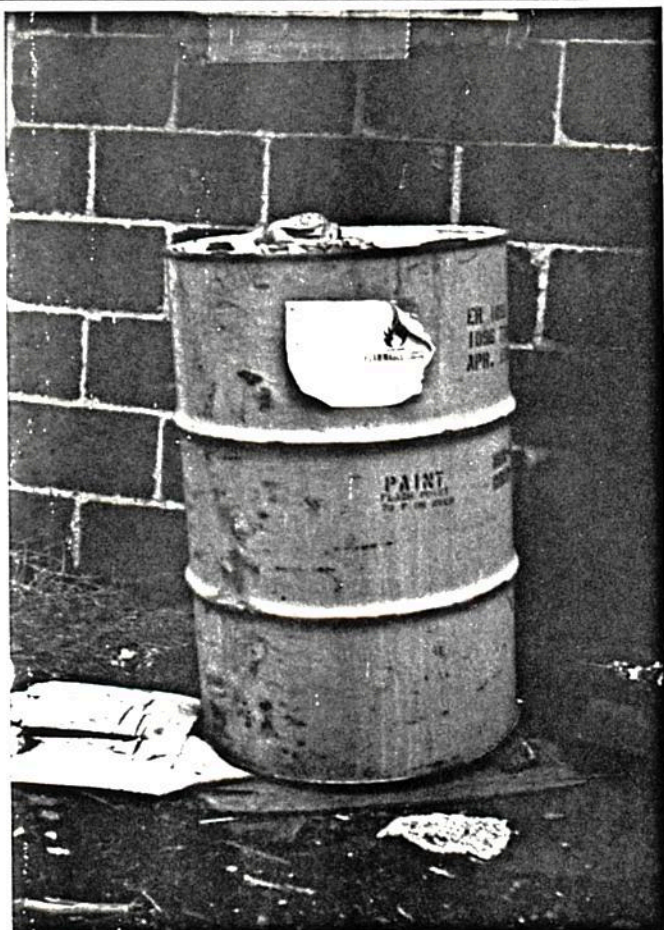
The Site Inspection Team arrived at the site at approximately 11:00 a.m. The skies were overcast, and the temperature was approximately 40°F. There was little wind. The team, carrying an ENMET CgS-100 gas meter, entered the site from the east, between two vandalized buildings. There is no gate at the entrance to the site. An abandoned truck with a 1980 Maryland registration tag, and "Bucks Steel Drum" lettering on the side, was parked to the left of the entrance. To the right of the entrance sits a drum which appeared to be full. The drum is marked "Flammable Liquid" and "Paint - Flash Point 73°F or Over" (Photo #1).

1. Facing west. Abandoned Drum, grey-rusted. Drum full - label "flammable liquid, paint flash point 75° or over."
2. Facing southwest through building. Drums visible through building. Sides of building have been torn off. Drum in building - foreground - lies in sump full of black, oily material.

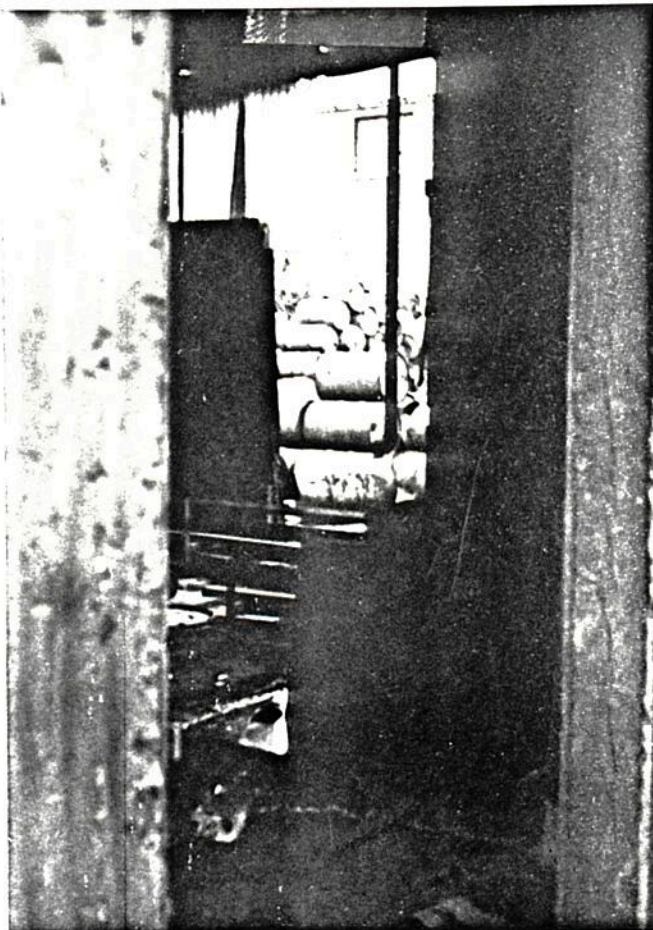
Walking west between the two buildings (#1 and #2), broken doors and windows can be noticed. The green, fiberglass siding has been ripped off Building #2, and drums can be seen when looking through the building (Photo #2). The buildings contain miscellaneous equipment, sumps full of oily liquid, and containers of various types. A container in Building #1 has leaked down the side, forming a hard, yellowish material (Photo #3).

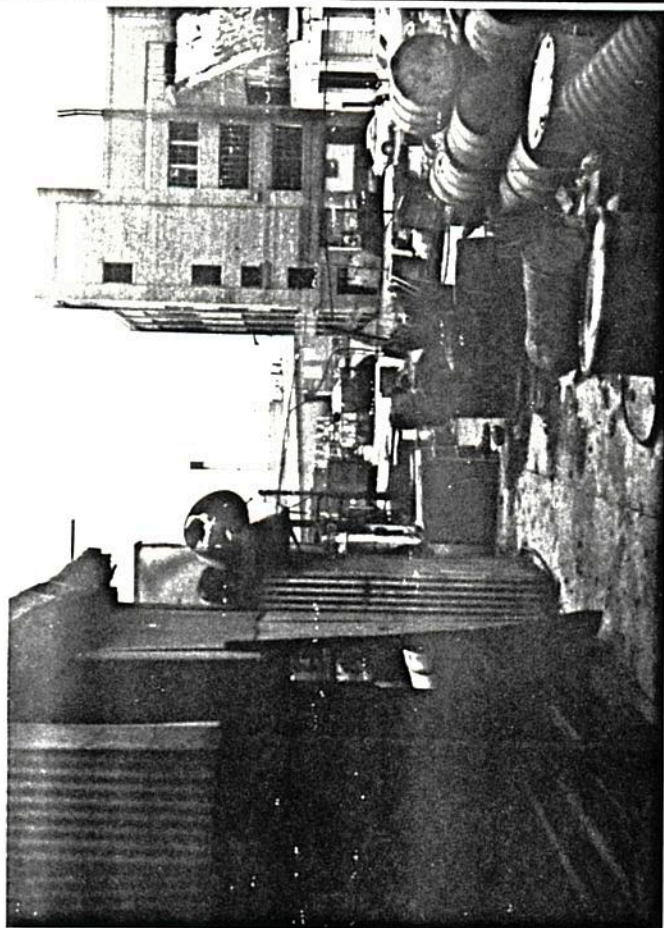
Walking south from Building #1, the metal siding has been ripped from Building #2, rusted drums are stacked haphazardly, and a portion of the incinerator smokestack lies on top of the building (Photo #4). The smokestack consisted of 6 or 7 55-gallon drums, minus tops and bottoms, which were welded together. Many abandoned drums are stacked along the western fence (see Map B-2 and Photos #6, 13, 20). Approximately 20-25% of these drums are full. Many are rusted and a few are bulging.

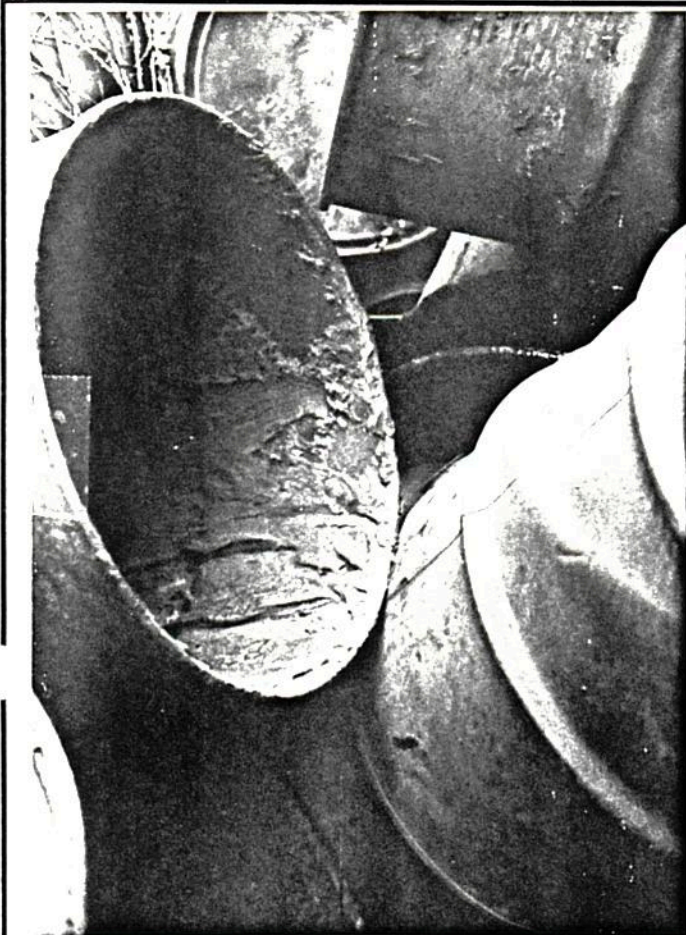
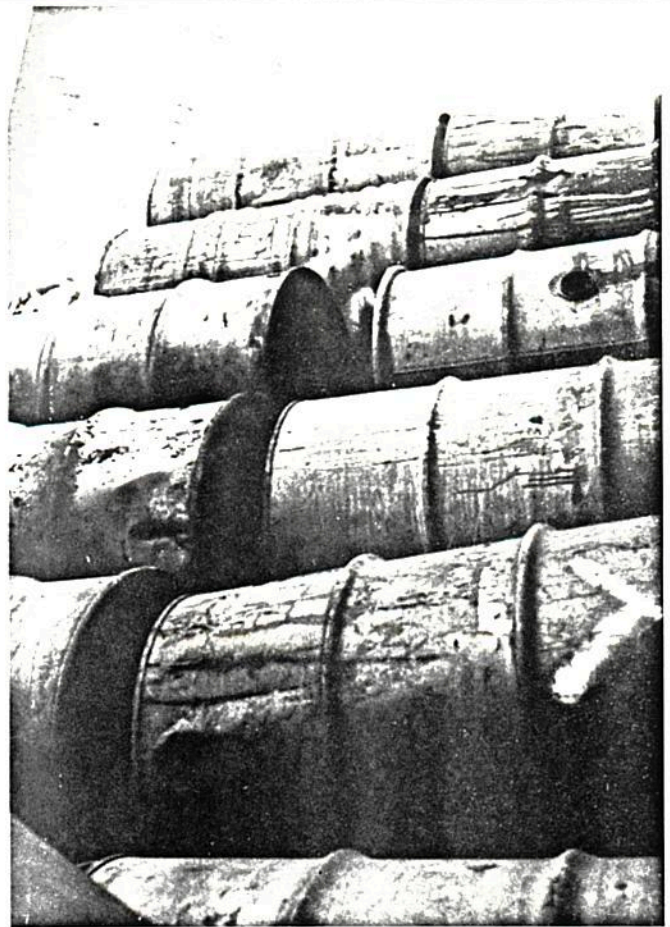
Approximately 100 drums are stacked behind Building #2, along the northern fence (Photo #8, 9, 10). There is a hole in the fence along the alley between the fence and Building #1.

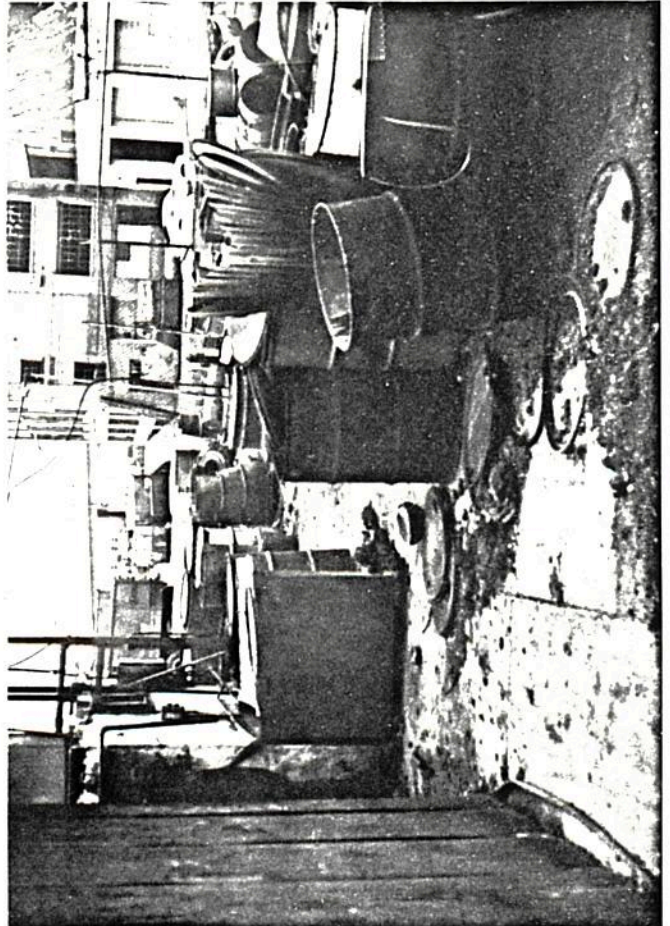
The incinerator shows evidence of uncontrolled operations. There are no doors or other devices to close off the combustion chambers from outside. The side of the incinerator is black and charred. There was no evidence of an afterburner or air pollution control devices. In Building #2 equipment is scattered, and several drums have been knocked over (Photo #15). Sumps in Building #2 are full of a black, oily material.

14. Facing south. Building #2 on left. Note incinerator on left (white structure). Note black, charred appearance. Material in foreground has been spilled from drums. Note fence in background has been broken.

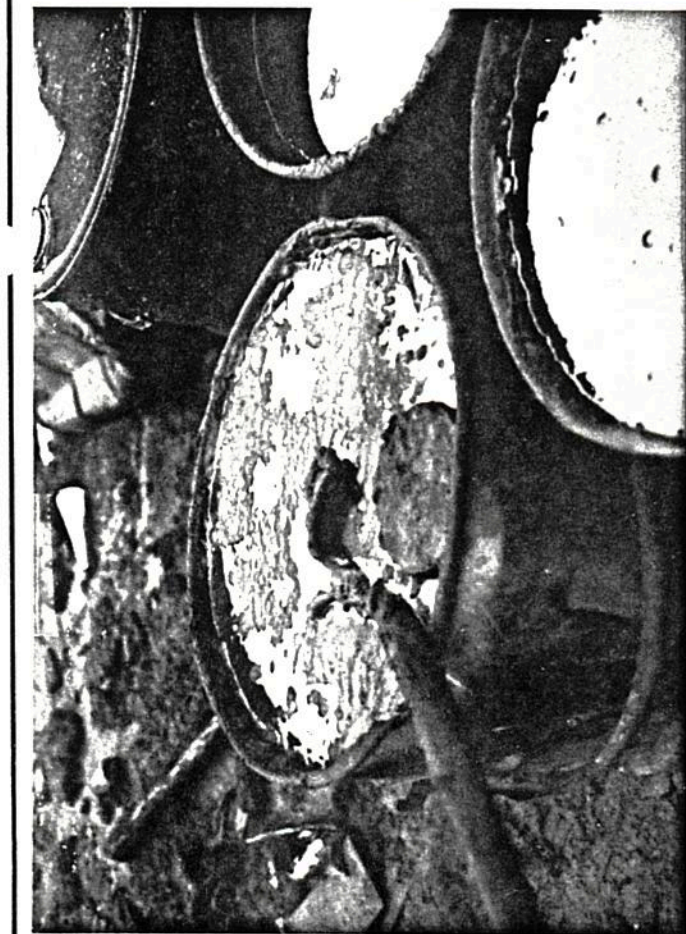
Along the outside of Building #2, south of the incinerator, are several drums which are open (Photos #16, 19, 20). These drums contain unidentified liquids which are green (Photo #18), black and viscous (Photo #17), and grey sludge with yellow and red supernatant on top (Photos #20, 21).

21. Facing west. Close up of drum shown in #20. Material is sludge with yellowish liquid on top. Drum in foreground has rust-colored liquid with oily sheen on top.

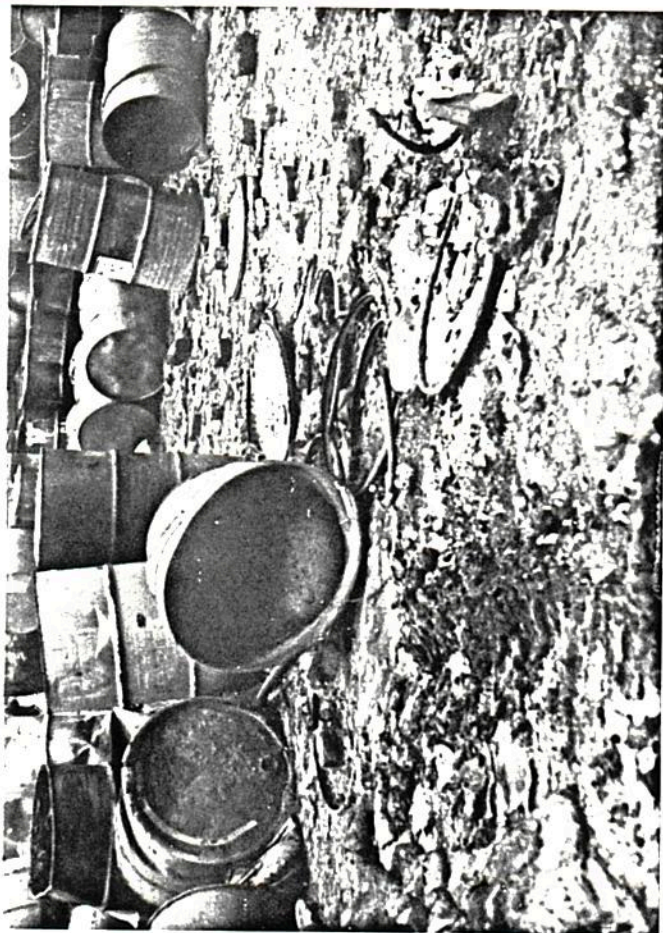
In the southwestern portion of the site, numerous drums have been spilled, crushed or punctured. Their contents have spilled on the ground forming a grey, sludge-like mass (Photos #20, 23, 24). This area shows evidence that a tracked vehicle has crushed several drums. An oily runoff is located along the southern boundary.

23. Facing north. Close up of spilled material described in #22. Drum to left, - background is full and rusted. Drum to center which is on side contains hardened mass like that spilled on ground.

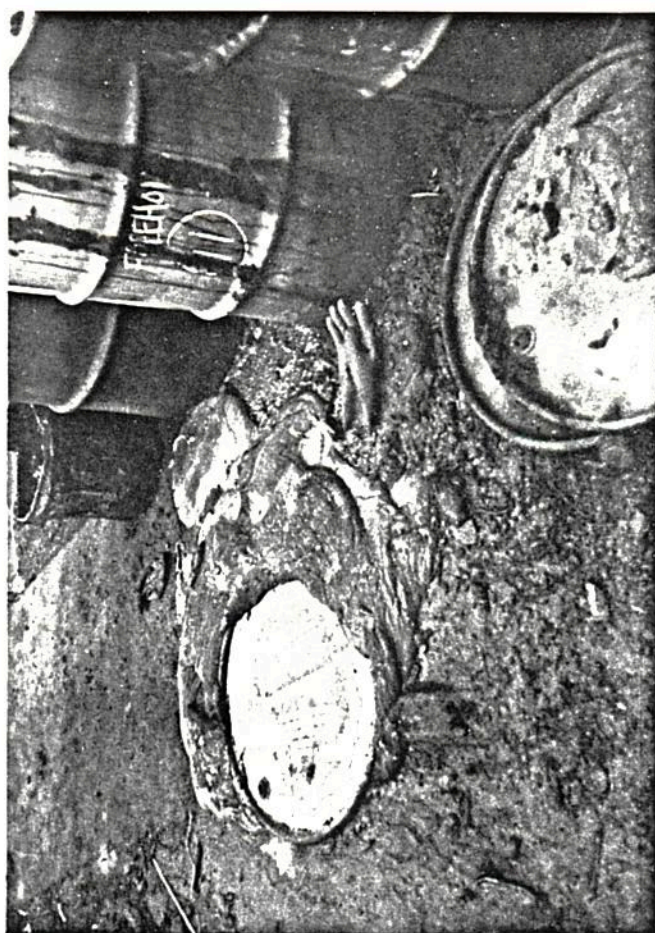
24. Facing east. Close up of spilled material. Material tan to black, Very hard. Soil in foreground covered with oil.
